Yuba County Self-Evaluation and Transition Plan for the Public Right-of-Way

County of Yuba

Department of Public Works

April, 2018

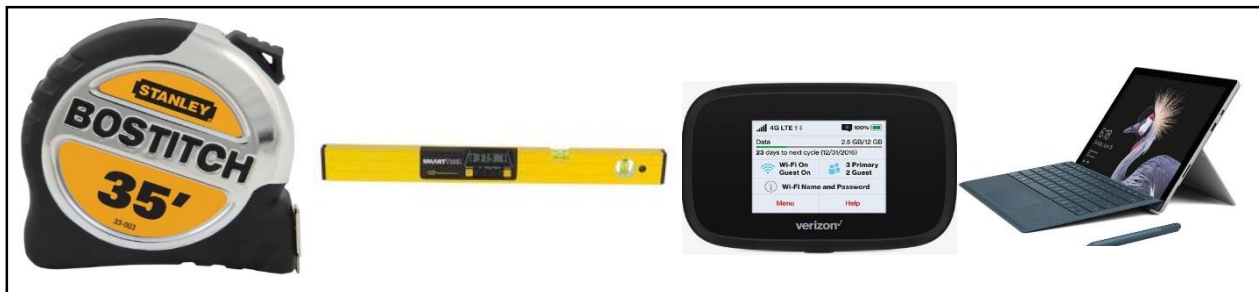
Figure 3: ADA Self-Evaluation tools from:

A Stanley Bostitch 35-foot measuring tape and a M-D Building Products SMARTTOOL were the materials used to take measurements at each facility. Two Microsoft Surface Pro tablets were leased to the Yuba County Department of Public Works for the Self-Evaluation program. Also, two Verizon Mifi devices were used to enable Wi-Fi access in the field. These tools are shown below in Figure 3.

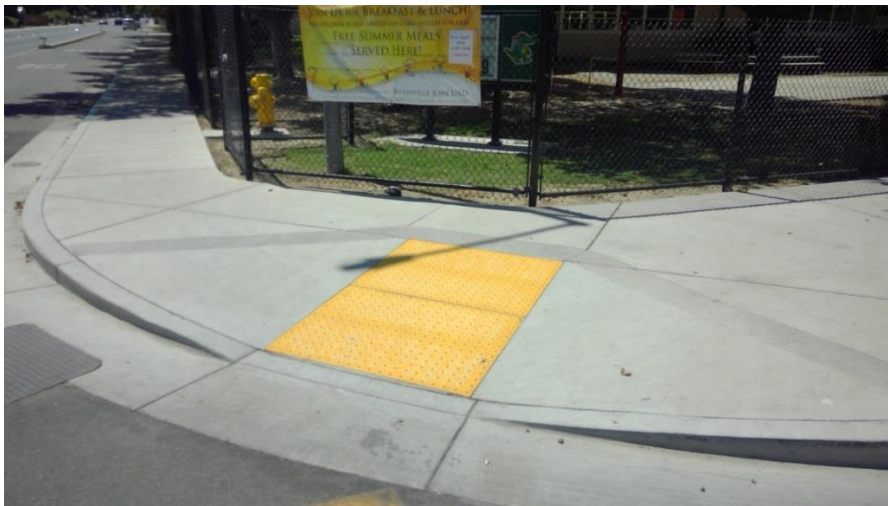
Figure 4: Example of curb ramp compliant with ADA standards (Data entry #38)

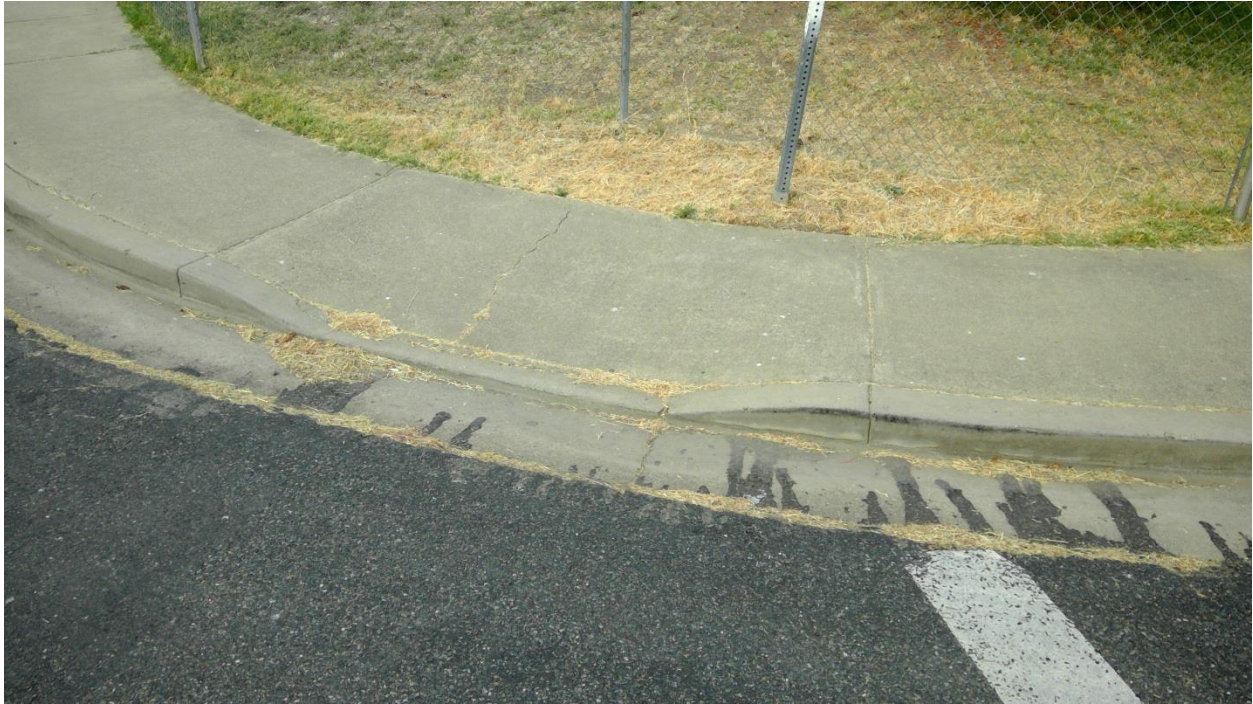
The ramp in Figure 5 did not meet the 2010 standards for a variety of reasons. While it met the standards for ramp cross slope and ramp width, the curb ramp had slope values above the allowable design for the ramp slope, right and left flare slope, and the gutter slope. There is also no top landing attached to this curb ramp, but that is not always a necessary requirement.

Figure 5: Example of ADA non-compliant curb ramp (Data entry #181)
